SIGAR 16-16 Inspection Report

Afghan Ministry of Defense Headquarters:
\$154.7 Million Building Appears Well
Built, but Has Several Construction Issues
that Should Be Assessed

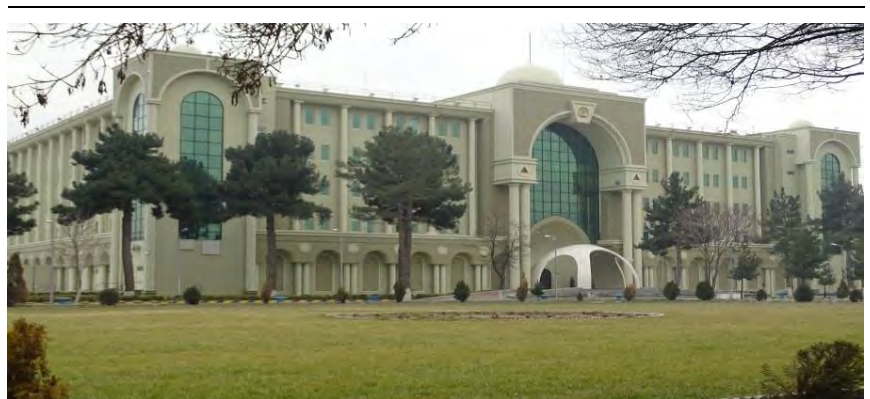
Afghan Ministry of Defense Headquarters Building in Kabul.

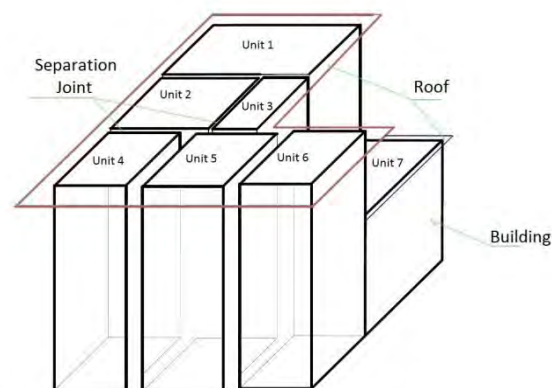
Figure 2 - Headquarters Building Sections Schematic

presents a schematic of the seven sections of the headquarters building and the separation joints that run from the foundation up to and through the roof. In addition to including separation joints to reduce damage to a structure during an earthquake, the building can include stronger walls, columns, and beams. Stronger walls called shear walls were included in this building. However, Building Unit 2 shear walls will not be strong enough to prevent the movement from exceeding the maximum allowable by the American Society of Civil Engineers standard 7.

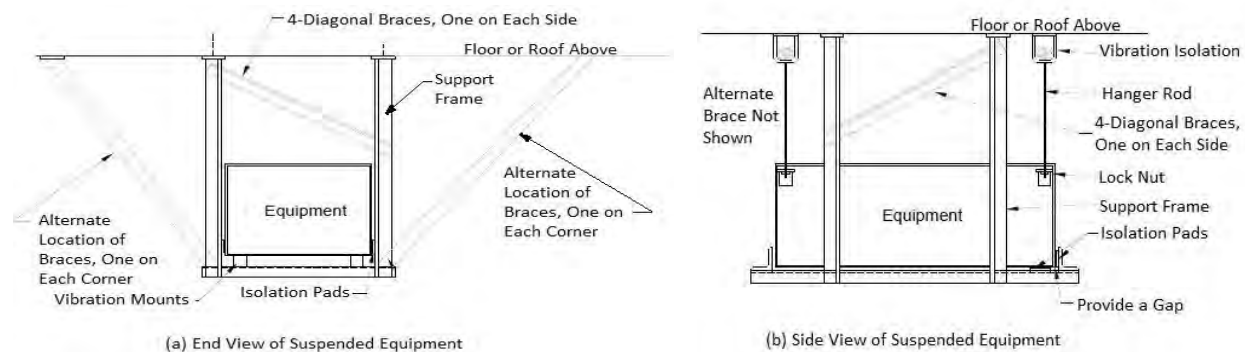
Figure 3 - Typical Seismic Restraints for Suspended Equipment

During our May 27, 2015, inspection, we found building equipment that did not have lateral bracing. Task orders 0030 and TG06 required that electrical and structural building standards, as defined in the Department of Defense's Unified Facilities Criteria, be followed in constructing the headquarters building.⁵ Based on the Unified Facilities Criteria, lateral bracing must be provided for items supported from the ceiling or floor above. Figure 3 shows typical seismic bracing, based on the Unified Facilities Criteria, used for equipment suspended from the ceiling or floor above.

4. Assess the integrity of lateral bracing, anchorage, isolation, and energy dissipation of all equipment for compliance with the contract's seismic requirements, and make deficient items compliant with the requirements.

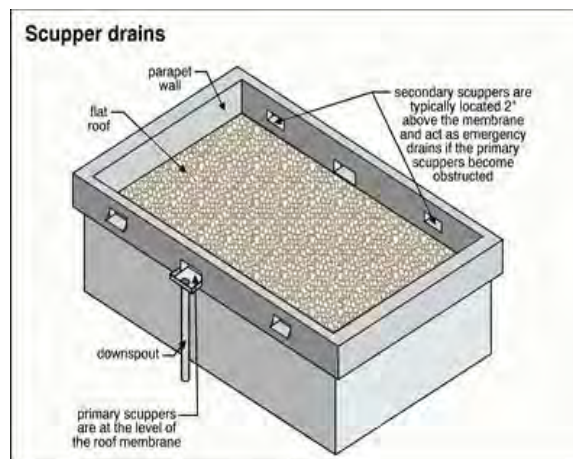
Figure 4 - Example of Secondary Drain for a Roof with Parapet Walls

During our 2015 inspections, we found that the roof was not designed or constructed in accordance with the contract and code requirements for roof drainage.⁷ For example, we found that the installed roof drains measured 3 inches, not the 4 inches in diameter required by the ITSI engineers' revised calculations. In addition, secondary drains, known as scuppers, were not installed. The contract design documents required—as does the building code—a secondary emergency overflow for roofs with a parapet wall (see figure 4 showing examples of secondary emergency roof drains).⁸ Otherwise, if storm water is trapped on the roof behind the parapet walls, it could (1) damage the ventilation and heating/cooling equipment that is roof mounted on 4-inch high platforms, and (2) allow water to enter the roof access doors and flood the building causing damage to equipment and interior finishes.
